AUTOMOTIVE ENGINEERING CONSULTANTS, INC.

Re: Style: _____
Subject: Preliminary report.
File No.: Ours. _____.

This report presents a distillation of data related to a S_____ Contracting, Inc. work truck accident that took place on September 12, 2006, at 4:35 p.m., at a work site on _____ Road, three miles east of _____, Washington. Two men, the truck driver and a helper, were working outside the truck erecting road signs.

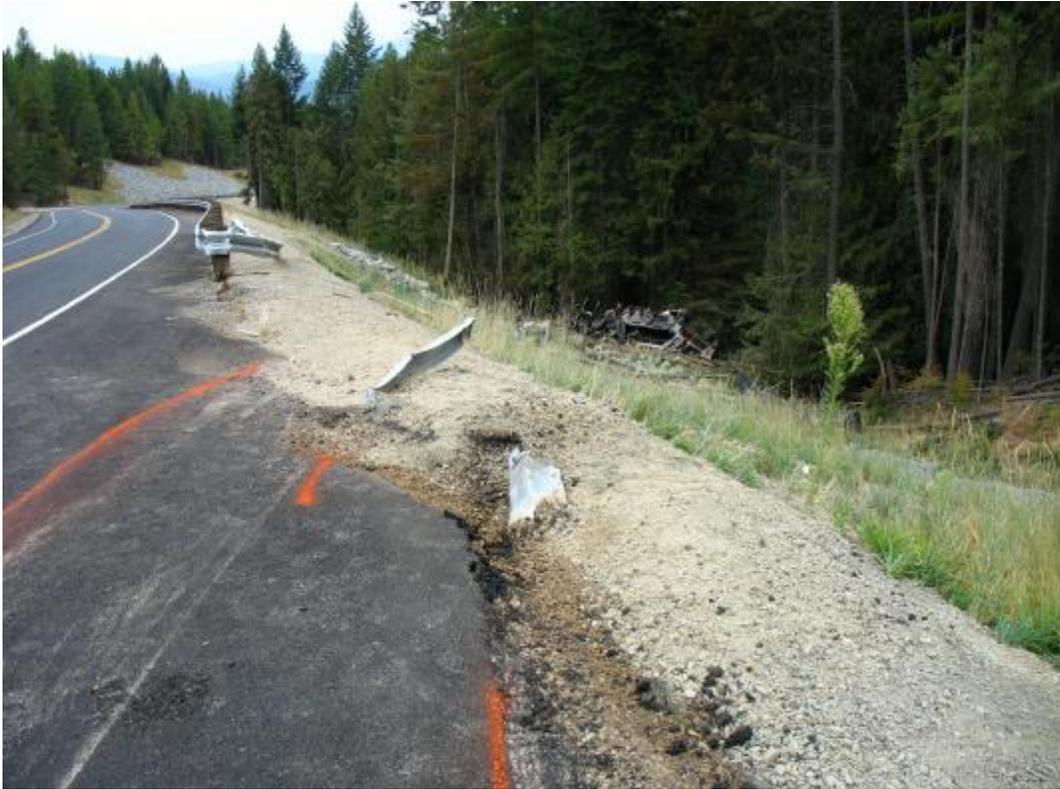
Photograph 1
Where the truck left the roadway.

Photograph 1, next page, is a photograph of the point where the accident truck and trailer left the roadway and crashed through the guard rail.

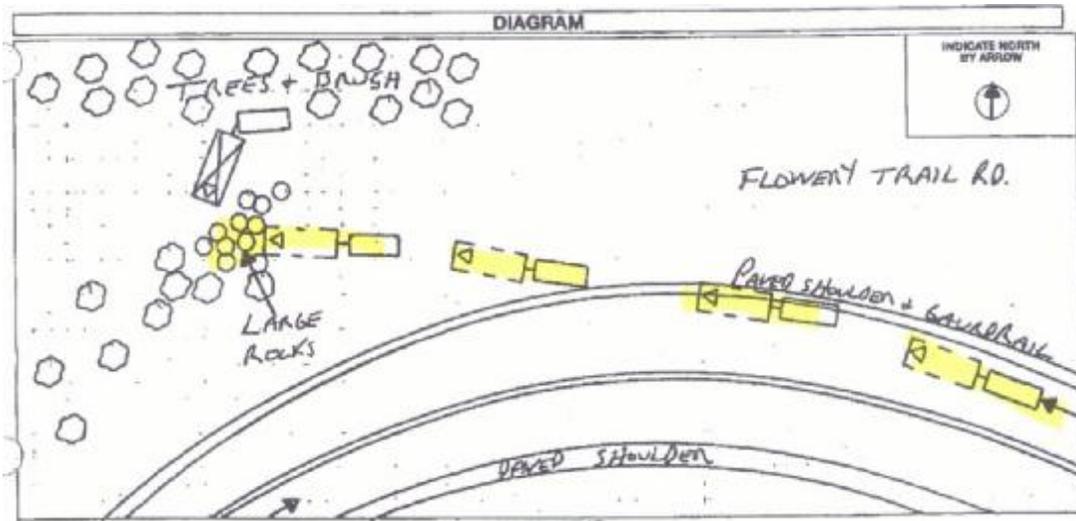
Figure 1
Police report schematic drawing of the crash scene.

Figure 1, next page, is a schematic drawing from the Police Traffic Collision Report of the crash location where the truck left the roadway.

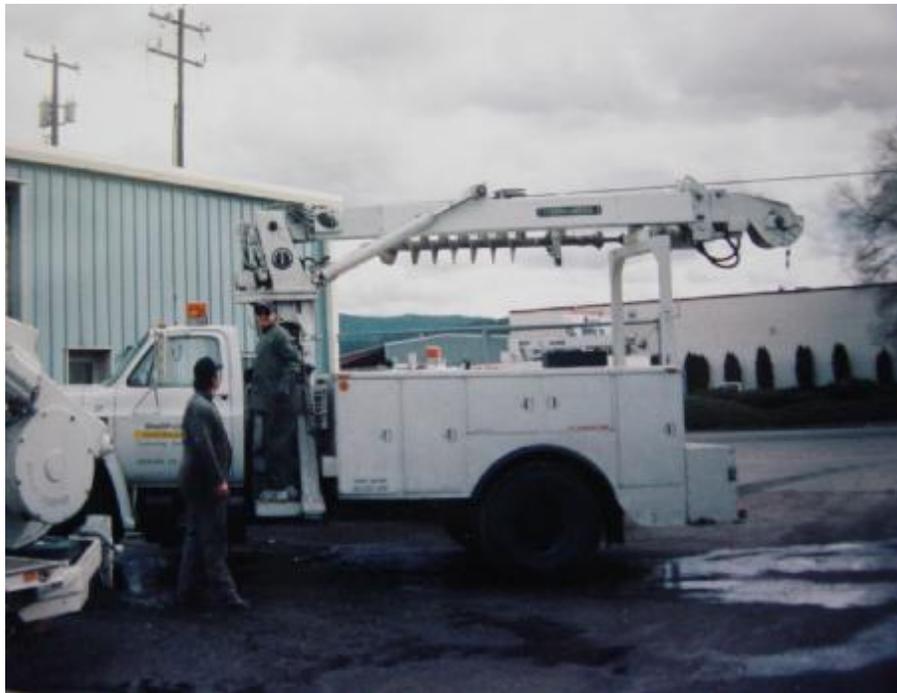
Photograph 2

The truck was equipped with a manual shift transmission, a power take-off unit, a boom mounted auger and outriggers.

The brake system in the accident truck is a single circuit hydraulic brake system utilizing a second, tandem master cylinder with a vacuum power brake booster.

Accident truck shortly after purchase in 1991.

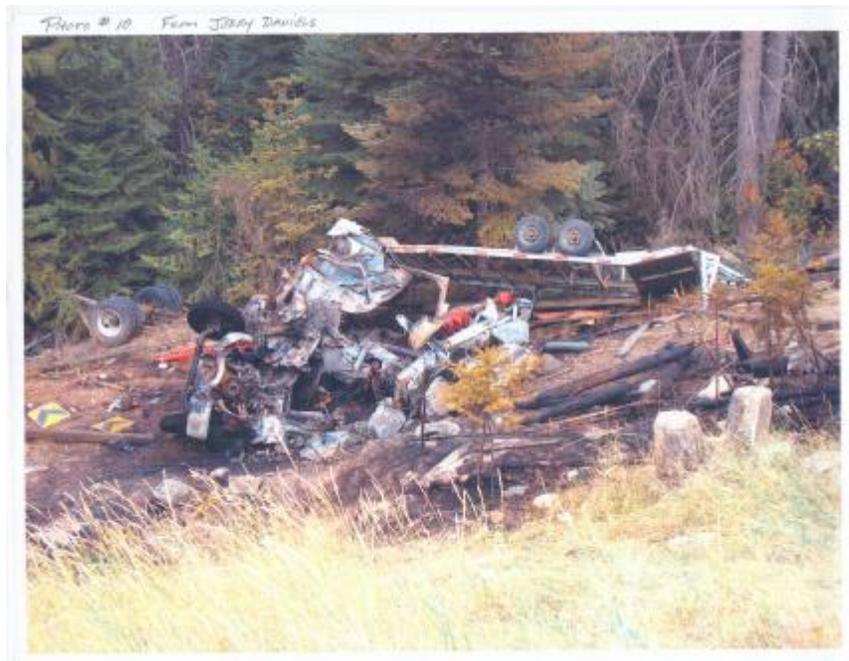
Photograph 3

3. A work trailer was being towed by the truck at the time of the accident. The trailer was equipped with electric brakes, controlled from inside the cab of the truck.
4. Accident scene. The S_____ Contracting, Inc. auger truck and work trailer lie at the bottom of the ravine after leaving the roadway, crashing through the guard rail, coming to rest and catching fire.

S_____ accident truck and work trailer at accident scene.

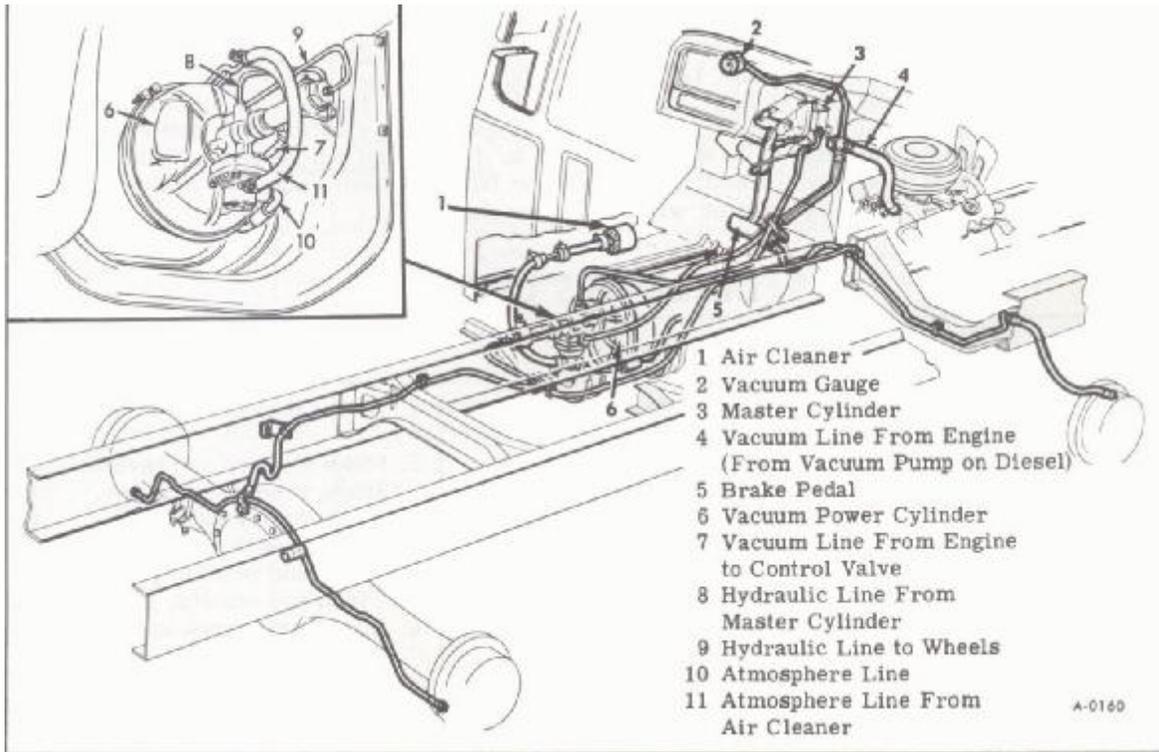
Figure 2
Chevrolet C65 Brake System

Figure 2 is from the Chevrolet C65 Medium Duty Truck Service Manual and is representative of the brake system in the accident truck.

The service brake system begins with the brake pedal connected to a master cylinder. The master cylinder converts the driver's foot pressure on the pedal to hydraulic fluid pressure in the brake lines and on to the brakes located at each wheel.

That additional force is provided by a second, larger power assisted master cylinder in tandem with the brake pedal master cylinder. The second master cylinder is assisted by a powerful vacuum booster, noted at position 6 in Figure 2, labeled Vacuum Power Cylinder.

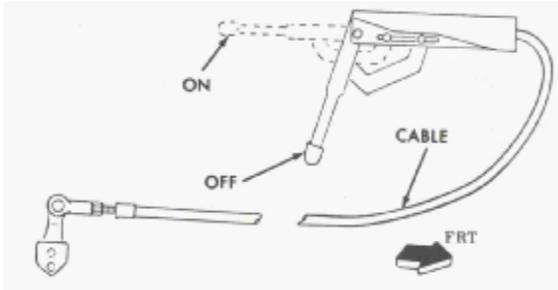
Figure 3
GMC Medium Duty Truck
Parking Brake Lever

The standard Chevrolet C65 parking brake is a transmission mounted drum brake coupled to the truck's drive shaft. The parking brake is manually activated from inside the cab of the truck by a rather large parking brake lever.

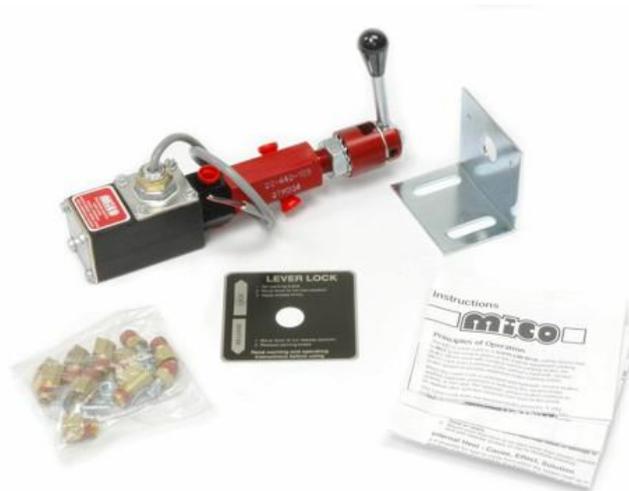
Photograph 4
M_____ Lever Lock Kit

The S_____ Contracting truck was equipped with an aftermarket, supplemental hydraulic parking brake, a M_____ Lever Lock. The complete M_____ kit is shown in photograph 4.

Once installed in the truck and plumbed into the truck's hydraulic brake pipe system, the M_____ Lever Lock can be activated by the small lever on the front of the device.

The M____ Lever Lock operates through an internal check valve that holds the brake line pressure that the driver generates by stepping on the brake pedal with the lever engaged.

Mr. _____ had recommended that the truck owners approve replacement of the existing dual system with a similar dual system. They declined and supplied a less expensive, single circuit M____ Lever Lock for installation, as sold to them by a local NAPA auto parts outlet.

24. M_____, by the year 2006, should not have recommended installing a single circuit supplemental hydraulic parking brake in a single circuit road vehicle's brake system. M_____ should have only recommended one of their dual systems.

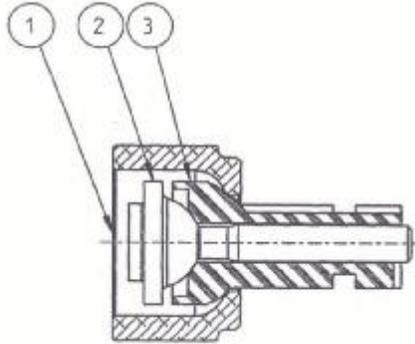
Figure 4
M____ Lever Lock check valve.

Figure 4 below, shows the M____ Lever Lock check valve, the active element of the device.

The check valve is located internal to the M____ Lever Lock (Photograph 4) in the red section approximately in the middle of the device.

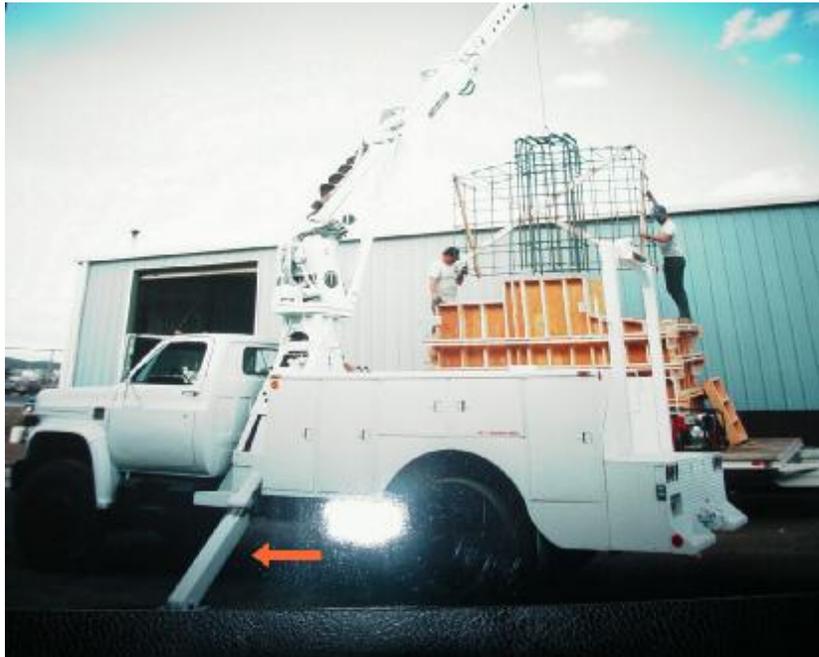
Photograph 5.
Outrigger deployed

Outriggers are arms that can be extended outward from the truck to help stabilize the truck during boom operations. When engaged with the surrounding ground, the outrigger picks up some of the truck's weight off the tires and onto the steel outrigger arms.

The outriggers not only stabilize the truck from side to side, but also help prevent the truck from rolling. Although not a part of the brake system proper, the accident truck was equipped with outriggers.

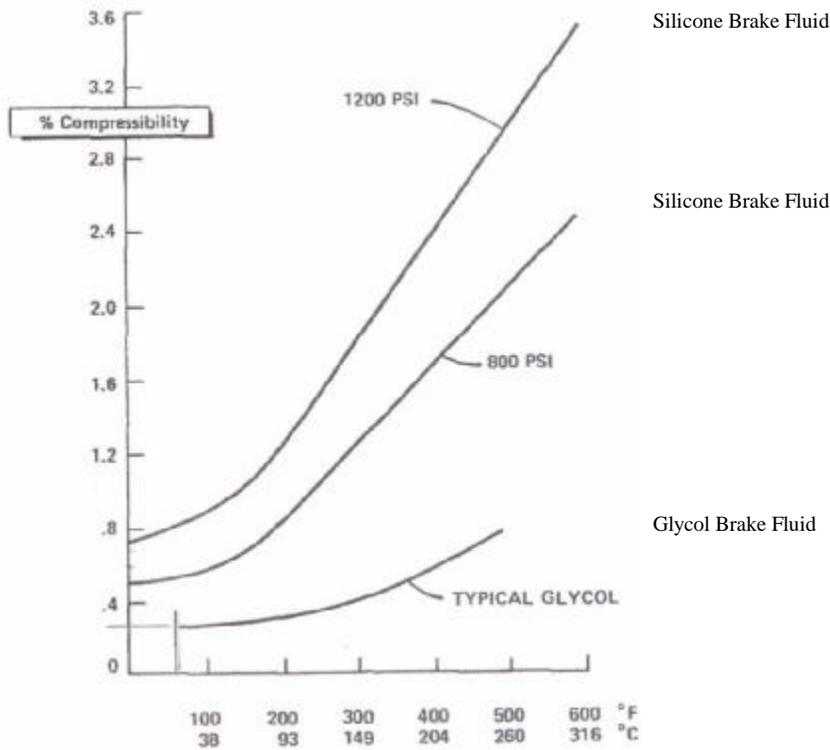
Figure 4.
Compressibility of Brake Fluid

In the figure below, from SAE paper 810803 , the compressibility of glycol brake fluid (DOT 3) at 75 °F is given as 0.3%. The two upper lines labeled 1200 p.s.i and 800 p.s.i. are for silicone brake fluid. The accident truck was equipped with glycol brake fluid.
